Draft Feasibility Report Dam Feasibility and Impact Analysis Macallen Dam, Newmarket, NH

Volume 2 of 2: Figures, Larger Tables and Appendices

Town of Newmarket, New Hampshire

June 2014

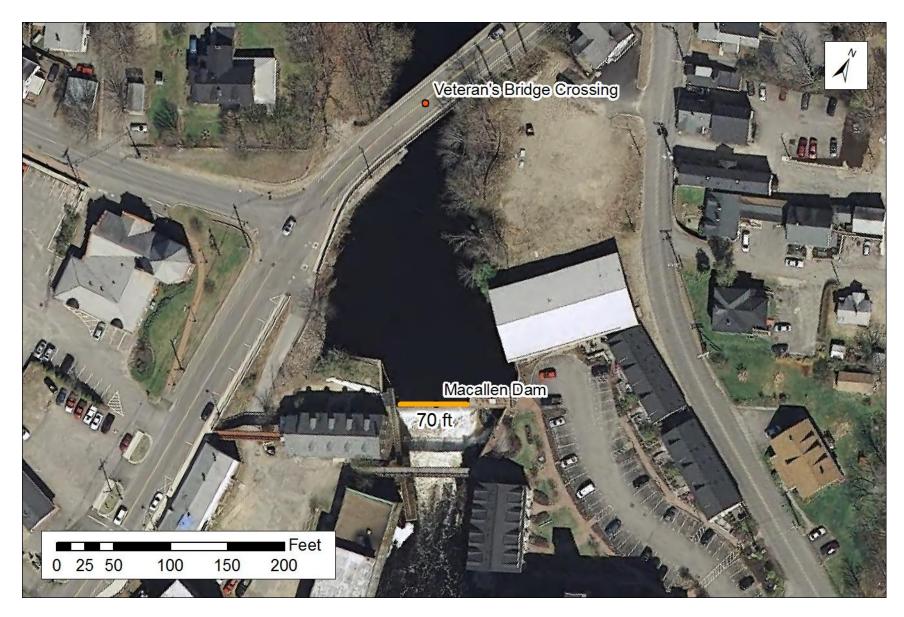
Figure 2.1-2: Aerial close-up of Macallen Dam

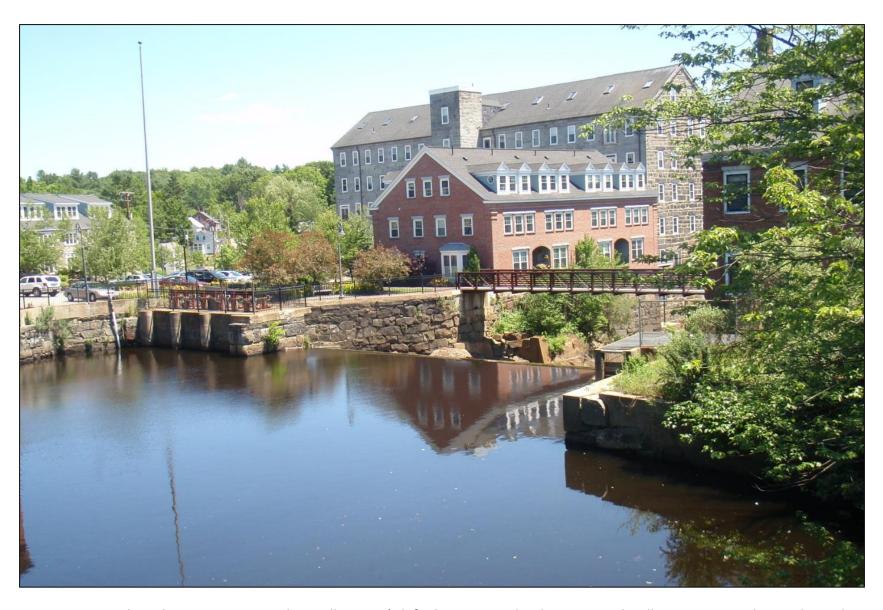
Figure 2.2-1: Looking downstream toward Macallen Dam's left abutment, right abutment and spillway sections. Photo taken July 2012.

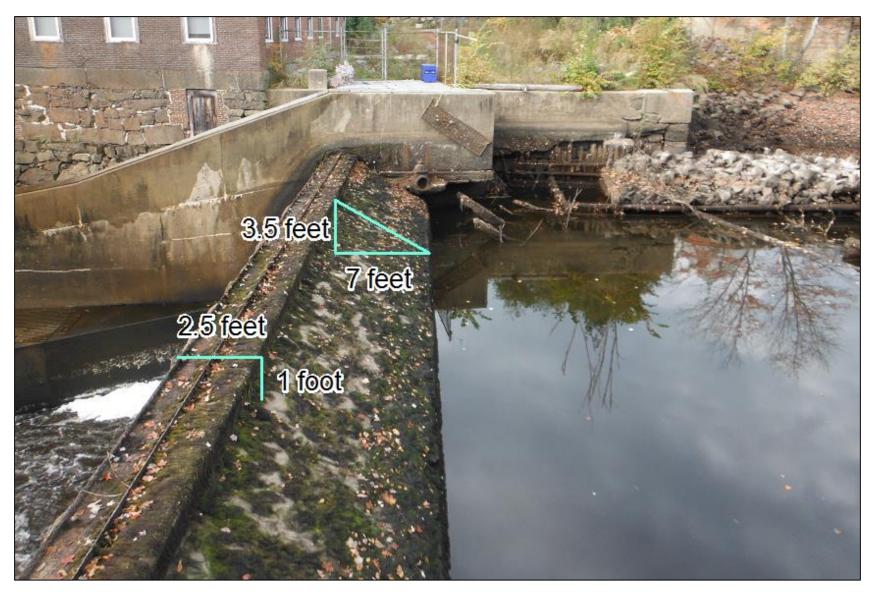
Figure 2.2-2: Photo of the dam's right abutment and spillway sections, including geometry of the sloped upstream face of the dam. Photo taken during the October 2013 drawdown. Note the metal lip running along the center of the spillway crest.

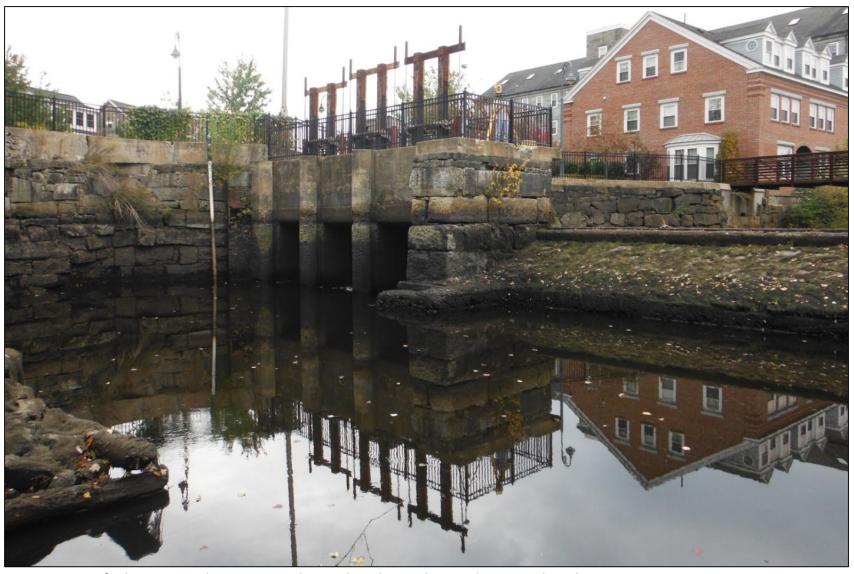
Figure 2.2-3: Left abutment and crest gates. Photo taken during the October 2013 drawdown.

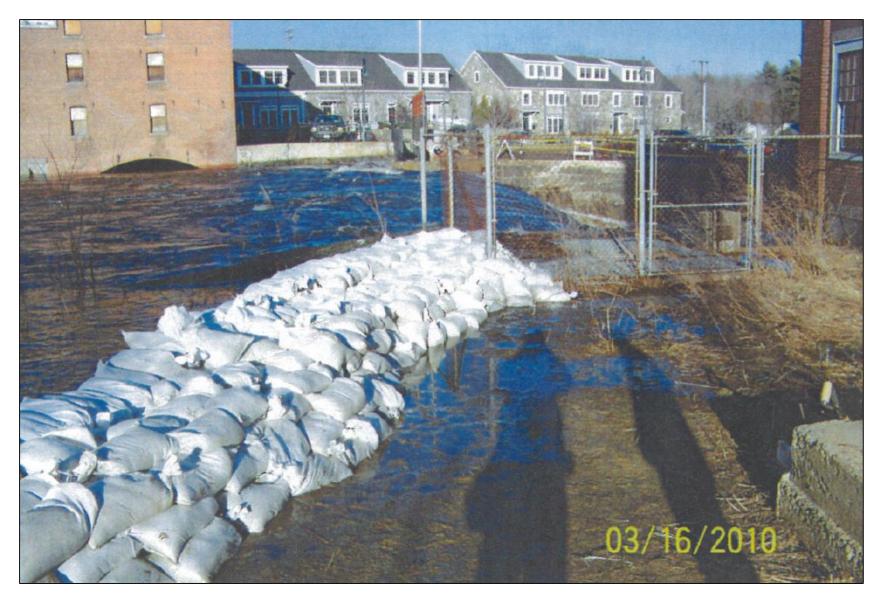
Figure 2.2-4: Macallen Dam during the March 16, 2010 flood event. Flow is approximately 6,710 cfs. Photo is taken from the right abutment, looking toward the spillway and left abutment. Photo source: NHDES Dam Bureau.

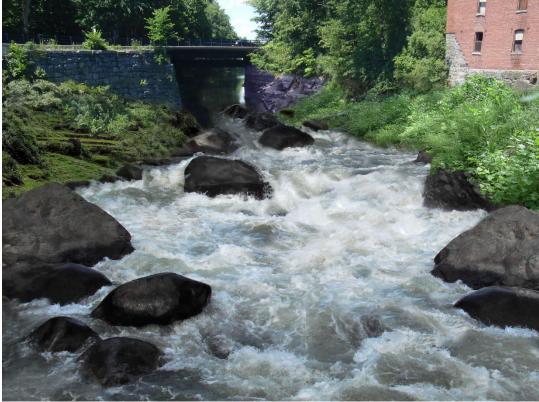
Figure 10.1-2: Visual rendering of Macallen Dam before and after removal
